U. S. Army
Coastal Engineering
Research Center

BEHAVIOR OF BEACH FILL
AND BORROW AREA AT
SHERWOOD ISLAND STATE PARK
WESTPORT, CONNECTICUT

TECHNICAL MEMORANDUM NO. 20
MAY, 1967

by
William H. Vesper

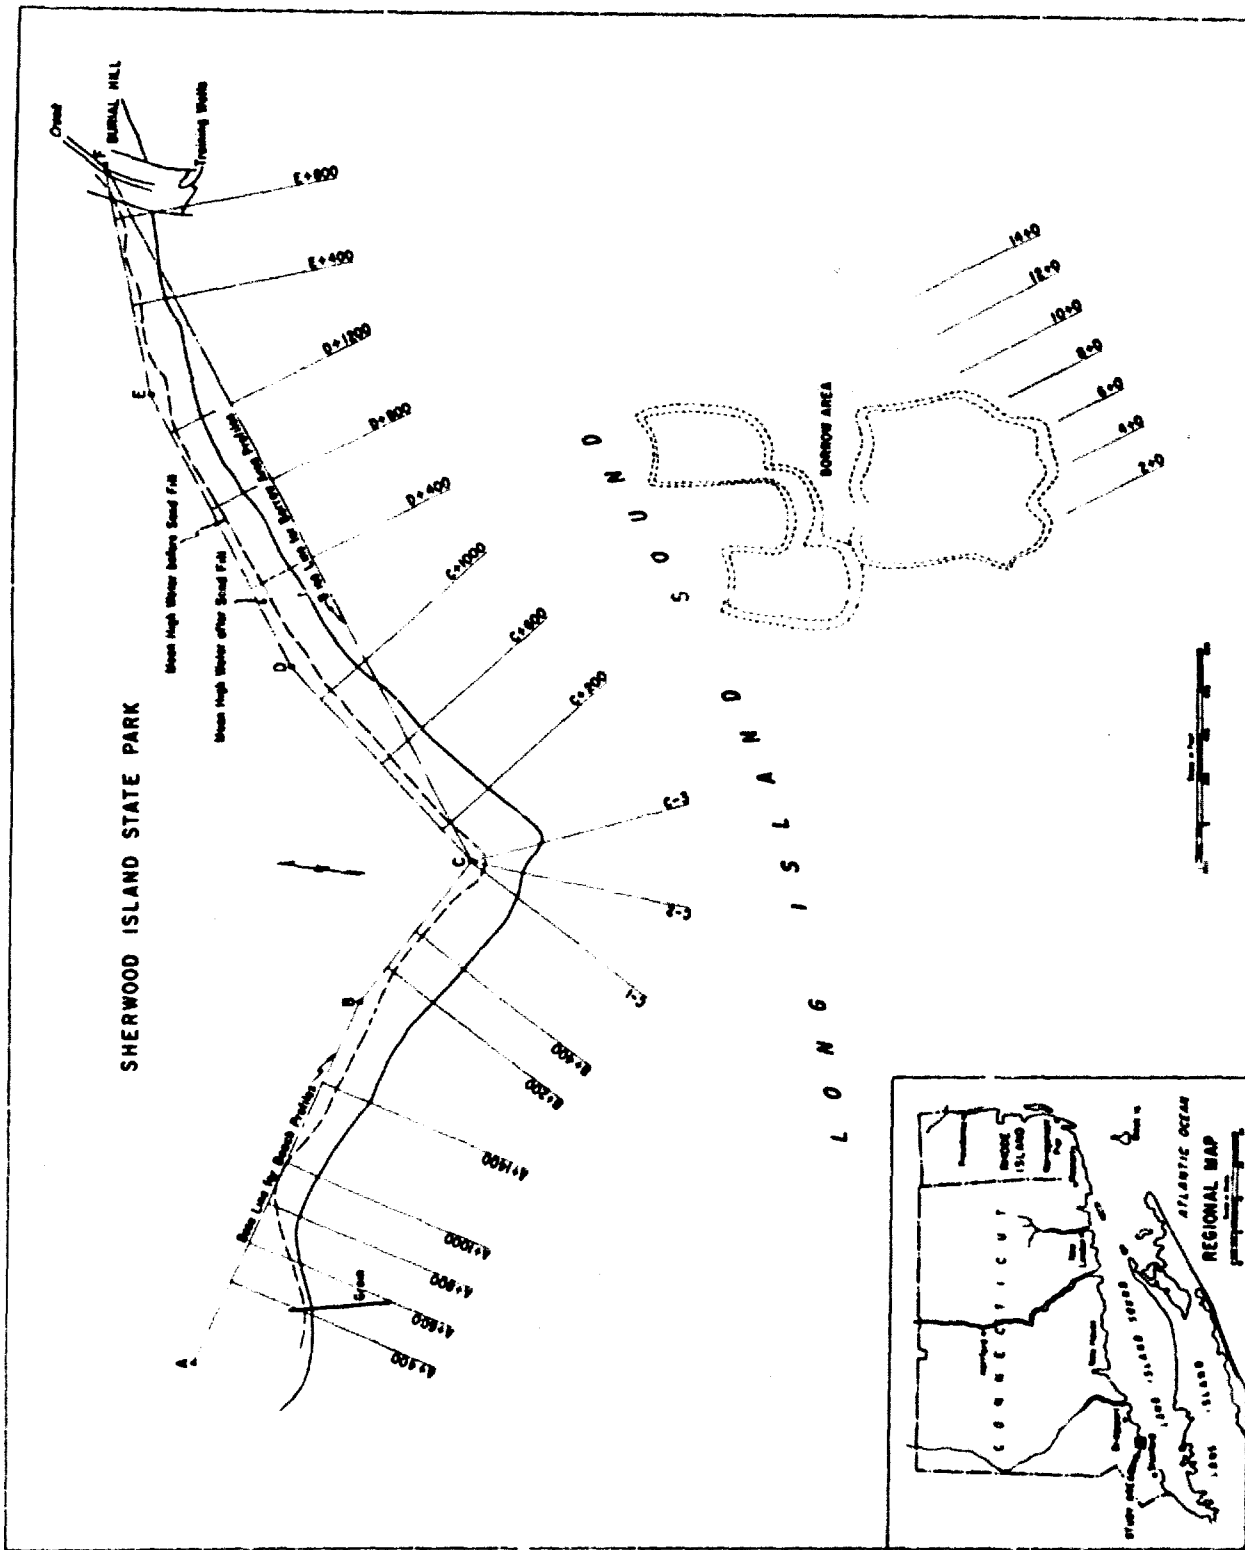
Figure 2. Location of Study Area Showing Profiles and Borrow Area

Sherwood Island State Park is located in the town of Westport, Connecticut (see Figure 2). Its shoreline extends generally northeast and northwest from Sherwood Point and is about 6,000 feet in length. In 1949, the U. S. Army Corps of Engineers, in cooperation with the State of Connecticut, completed a beach erosion control study of the Connecticut shore from Ash Creek to Saugatuck River which included Sherwood Island State Park.* The purpose of the cooperative study was to determine the most suitable methods of stabilizing and improving the shoreline. The study revealed that a natural source of supply of littoral material no longer existed within the area and that improvement of the shore could best be accomplished by artificial replenishment of the beaches. The most logical source of sand for this purpose was deemed to be offshore. A plan for improvement was developed and recommended which involved pumping sand onto the beach from an offshore borrow area, employing a hydraulic pipeline dredge. The plan, authorized as a Federal project under the 1950 River and Harbor Act, provided for widening approximately 6,000 feet of beach to a 150-foot width above mean high water by direct placement of sand, creation of a stockpile by placement of sand to an additional width of 100 feet over a distance of 1,000 feet both east and west from Sherwood Point, construction of two training walls 400 and 500 feet in length at Burial Hill Creek, construction of an impermeable rubble groin 500 feet long at the west end of the park, and maintenance of the improved beach by periodic nourishment.

In March 1955, about 21 months before fill placement, 31 profiles of the shore and offshore bottom were surveyed generally at 200-foot intervals (ranges A+600 to E+800 - see Figure 2). All ranges were resurveyed immediately after the fill placement in June 1957 and the surveys were repeated again in November 1957 and June 1958. A condition survey of Sherwood Island was made in June 1962; however, during this survey, only 17 selected ranges were resurveyed because of limited funds. The borrow area was sounded along 13 ranges in August 1957 after dredging at 100-foot intervals (ranges 2+00 to 14+00, inclusive, Figure 2). These soundings were compared with those taken along the even-numbered ranges earlier in 1957 before dredging. During the June 1962 survey, the borrow area was again sounded along the seven even-numbered ranges (2+00 to 14+00).

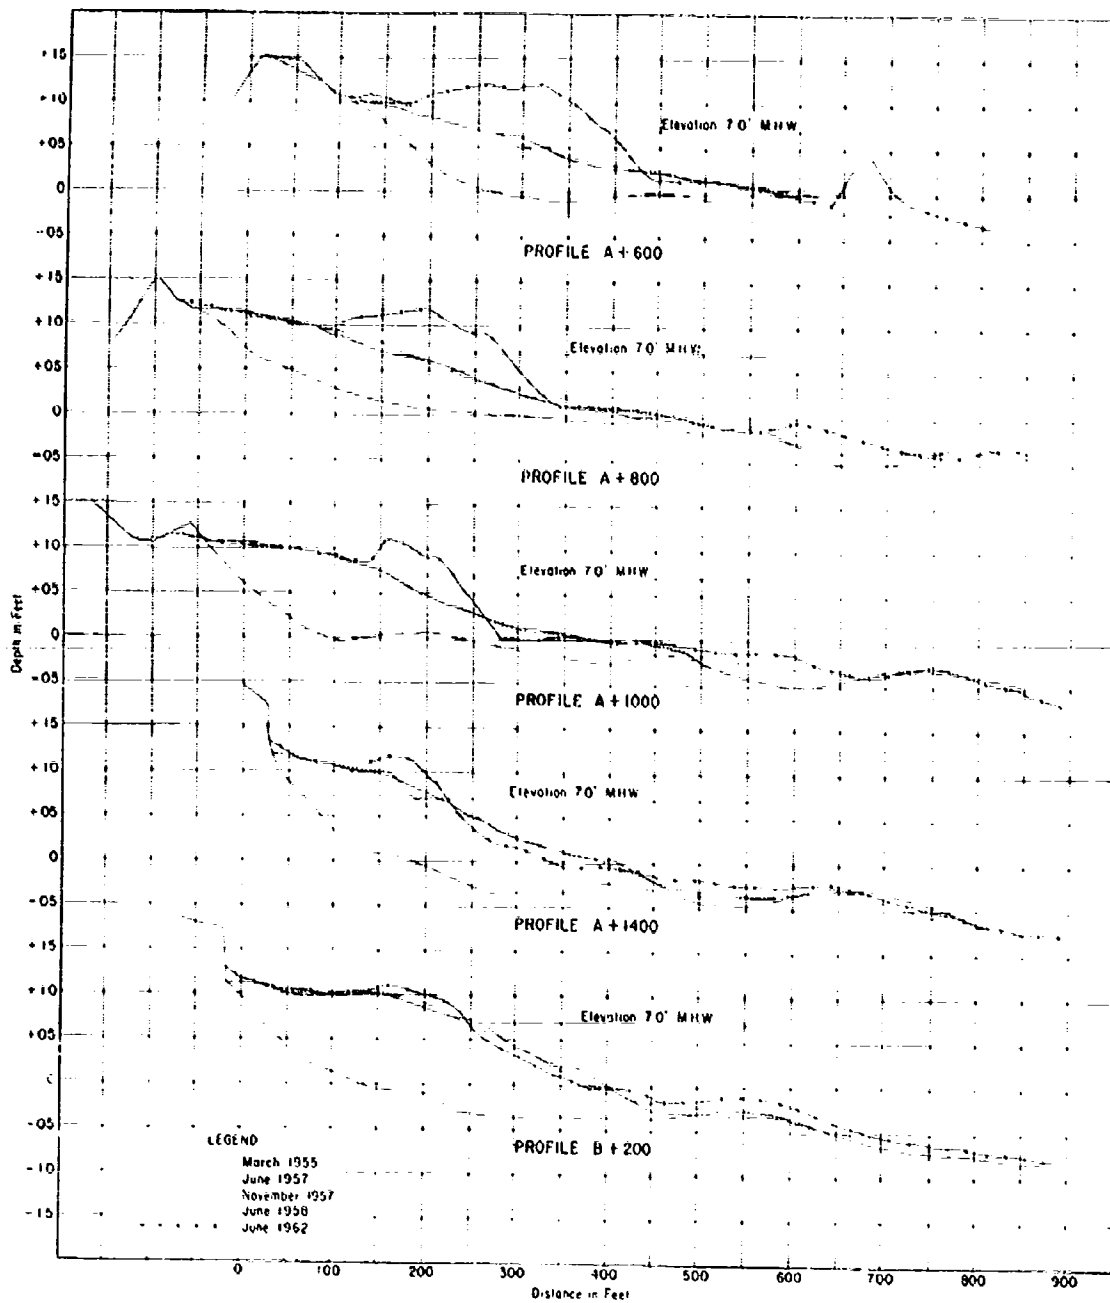
Figure 3. Comparative Profiles A+600 Through B+200

Comparative profiles obtained from 5 surveys from 1955 through 1962 are shown in Figures 3 through 6. Successive profiles of the same range either close or approach to within one foot of closure from 600 to 800 feet offshore of the baseline. Profiles of the four ranges in the western sector (ranges A+600 to A+1400) close at about 600 to 750 feet offshore of the baseline and, except for range A+600, in depths of 3.0 to 3.5 feet. Range A+600 extends through the impounding area of the stone groin at the western end of the park and profiles of this range close at about mean low water. Profiles of the remaining ranges at Sherwood Park do not completely close; however, they do converge to within one foot of closing. Except for range C-3, profiles of ranges located at Sherwood Point and in its vicinity (ranges B+200 to C+600) approach closure from 650 to 850 feet offshore of the baseline in depths of from 7 to 12 feet. Range C-3 extends through Sherwood Point and profiles of this range converge to within one foot of closing at about 540 feet offshore of the baseline in a depth of from 4 to 5 feet.

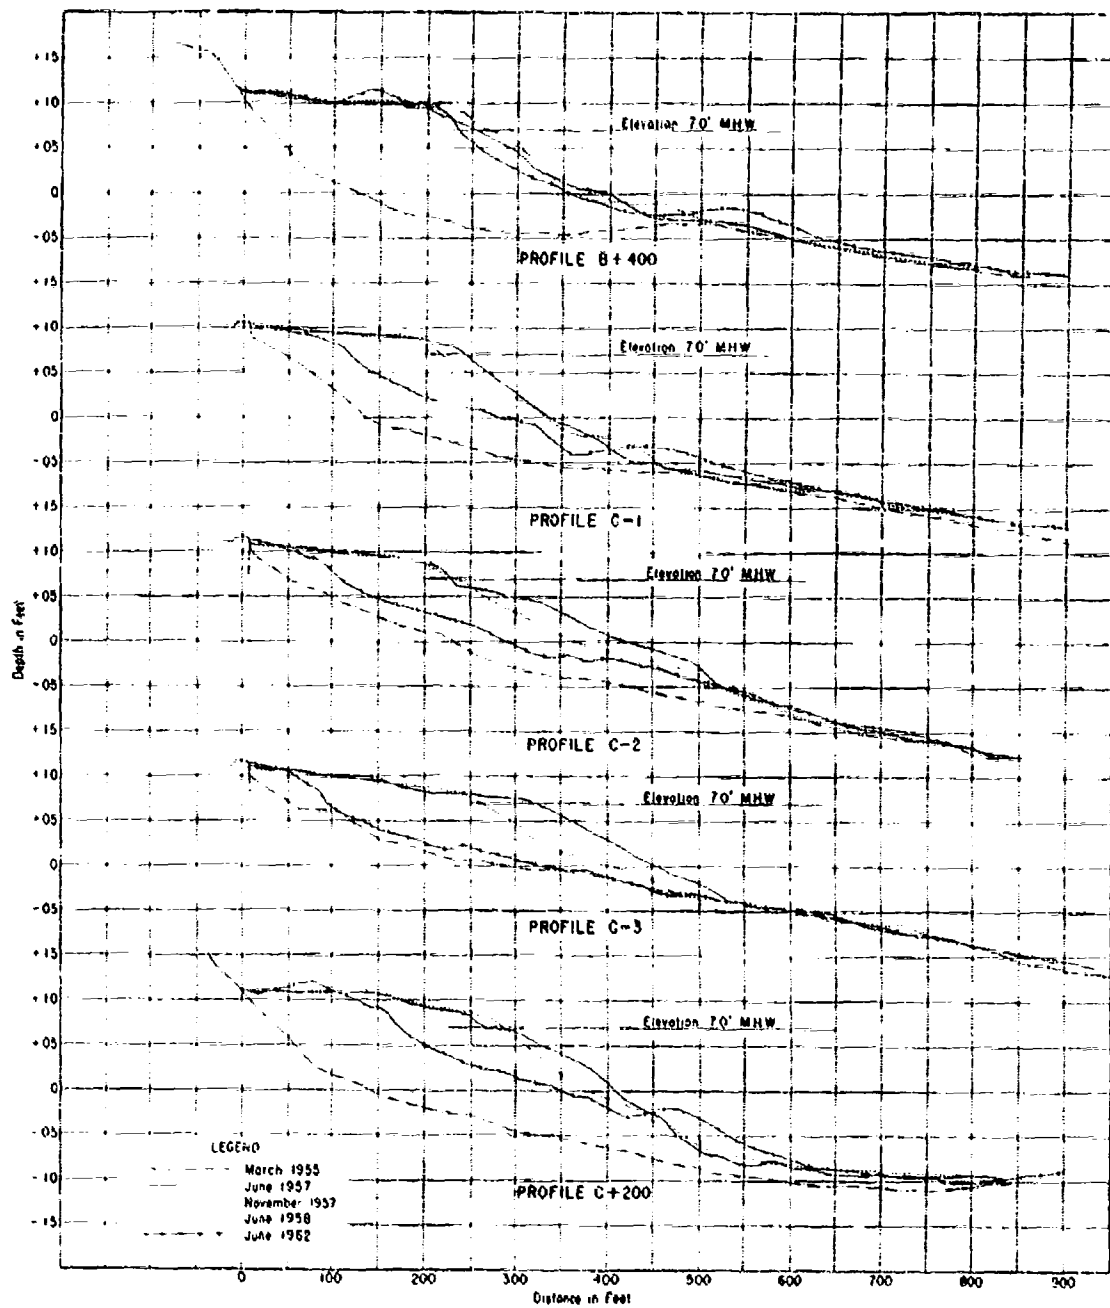
Figure 4. Comparative Profiles B+400 Through C+200

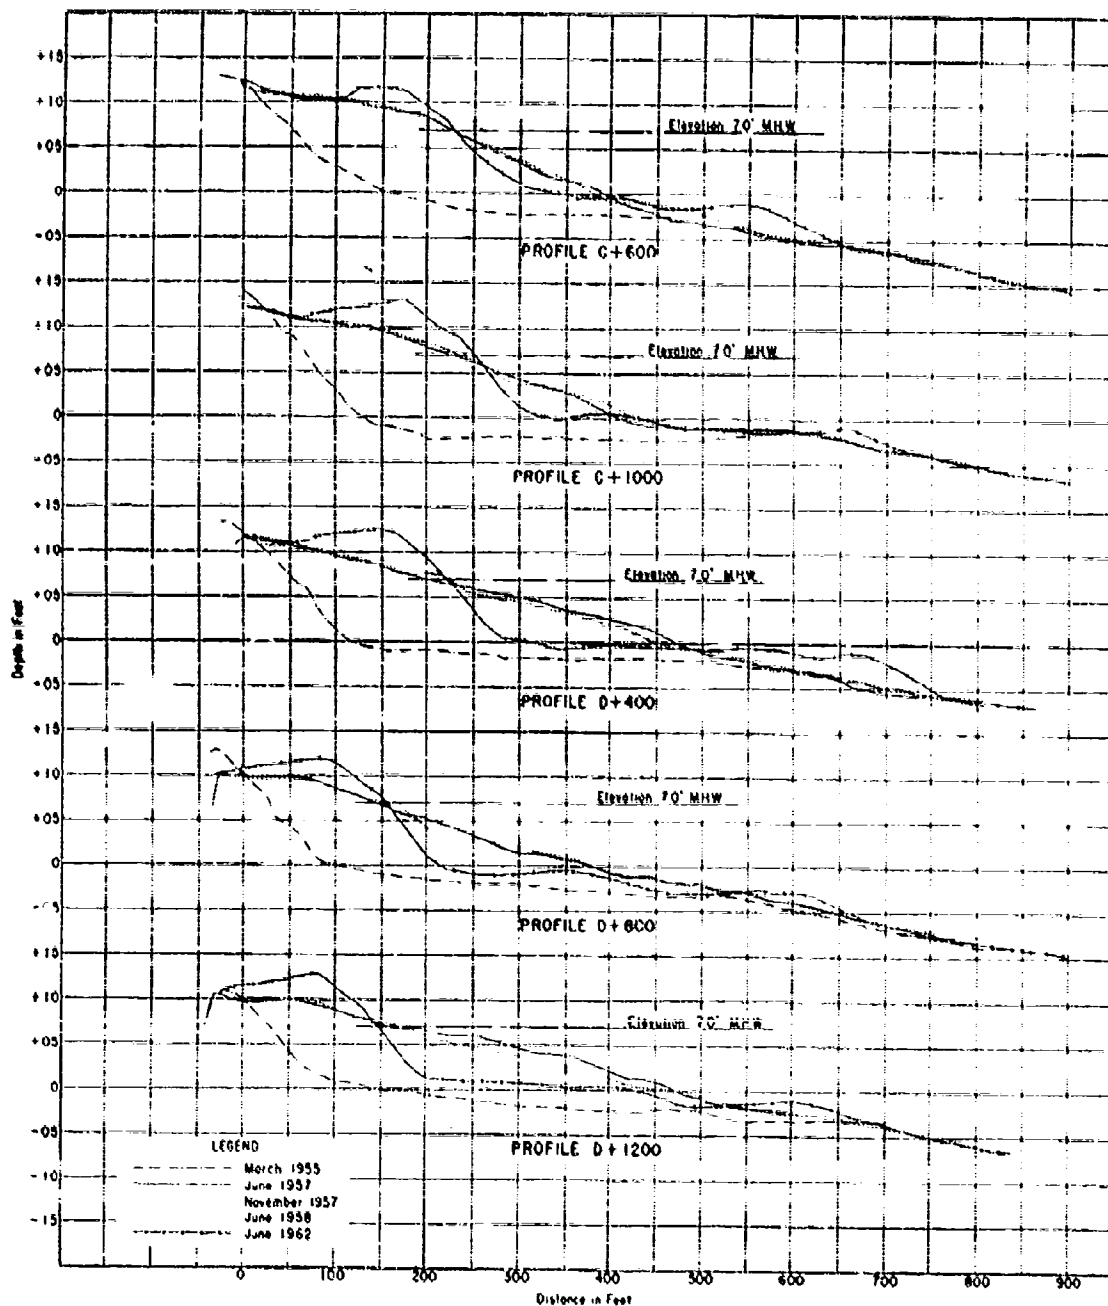
Figure 5. Comparative Profiles C+600 Through D+1200

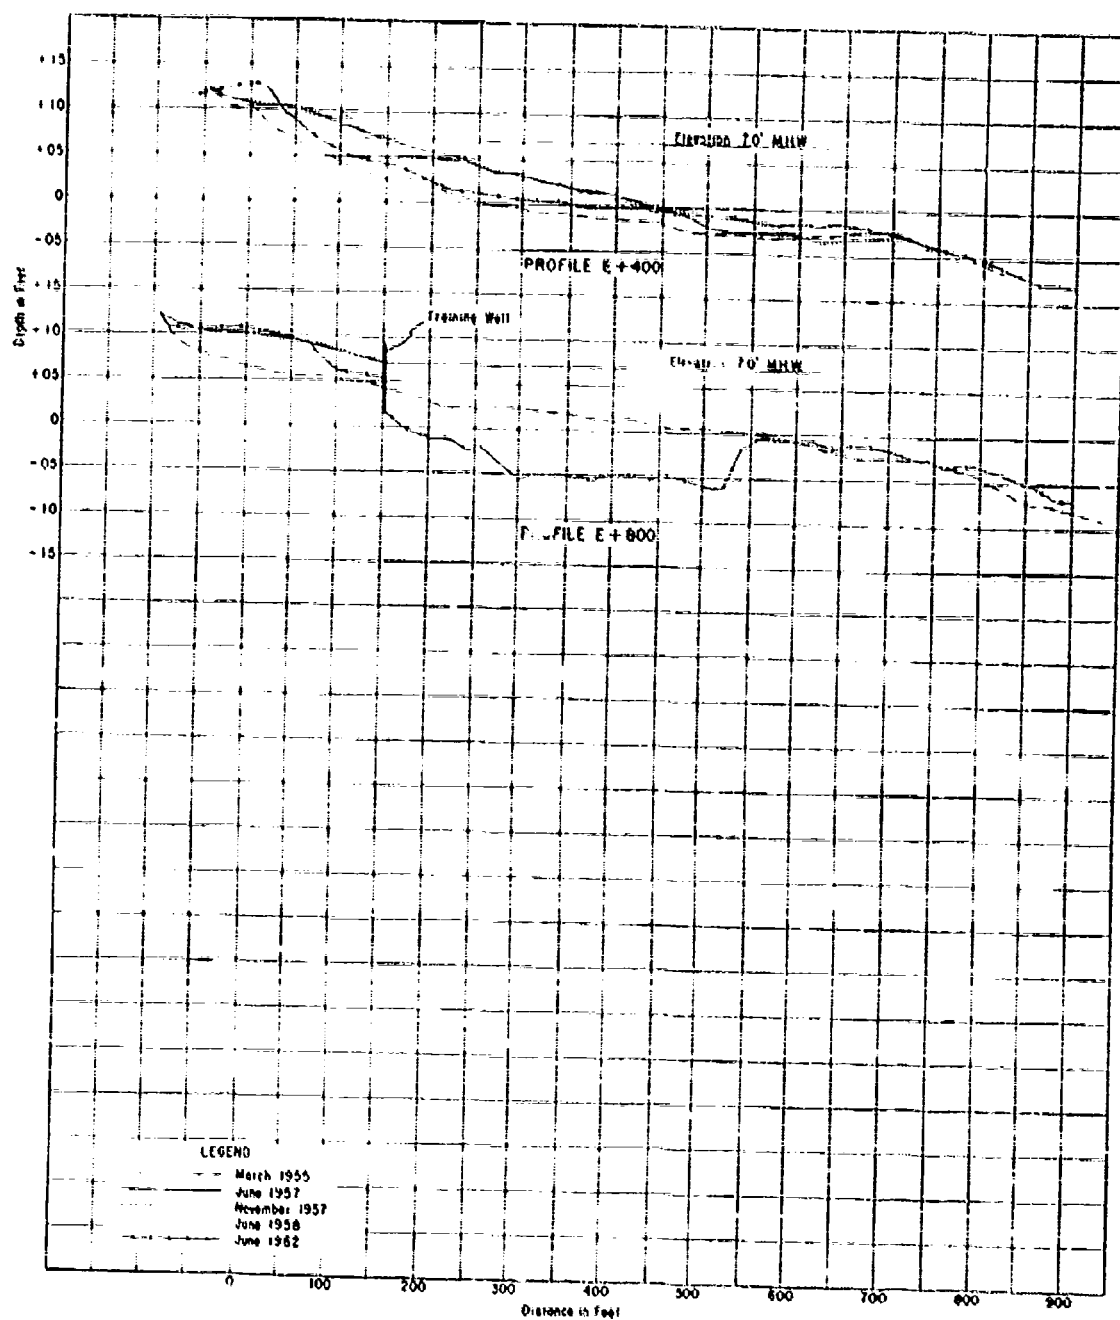
Figure 6. Comparative Profiles E+400 and E+800

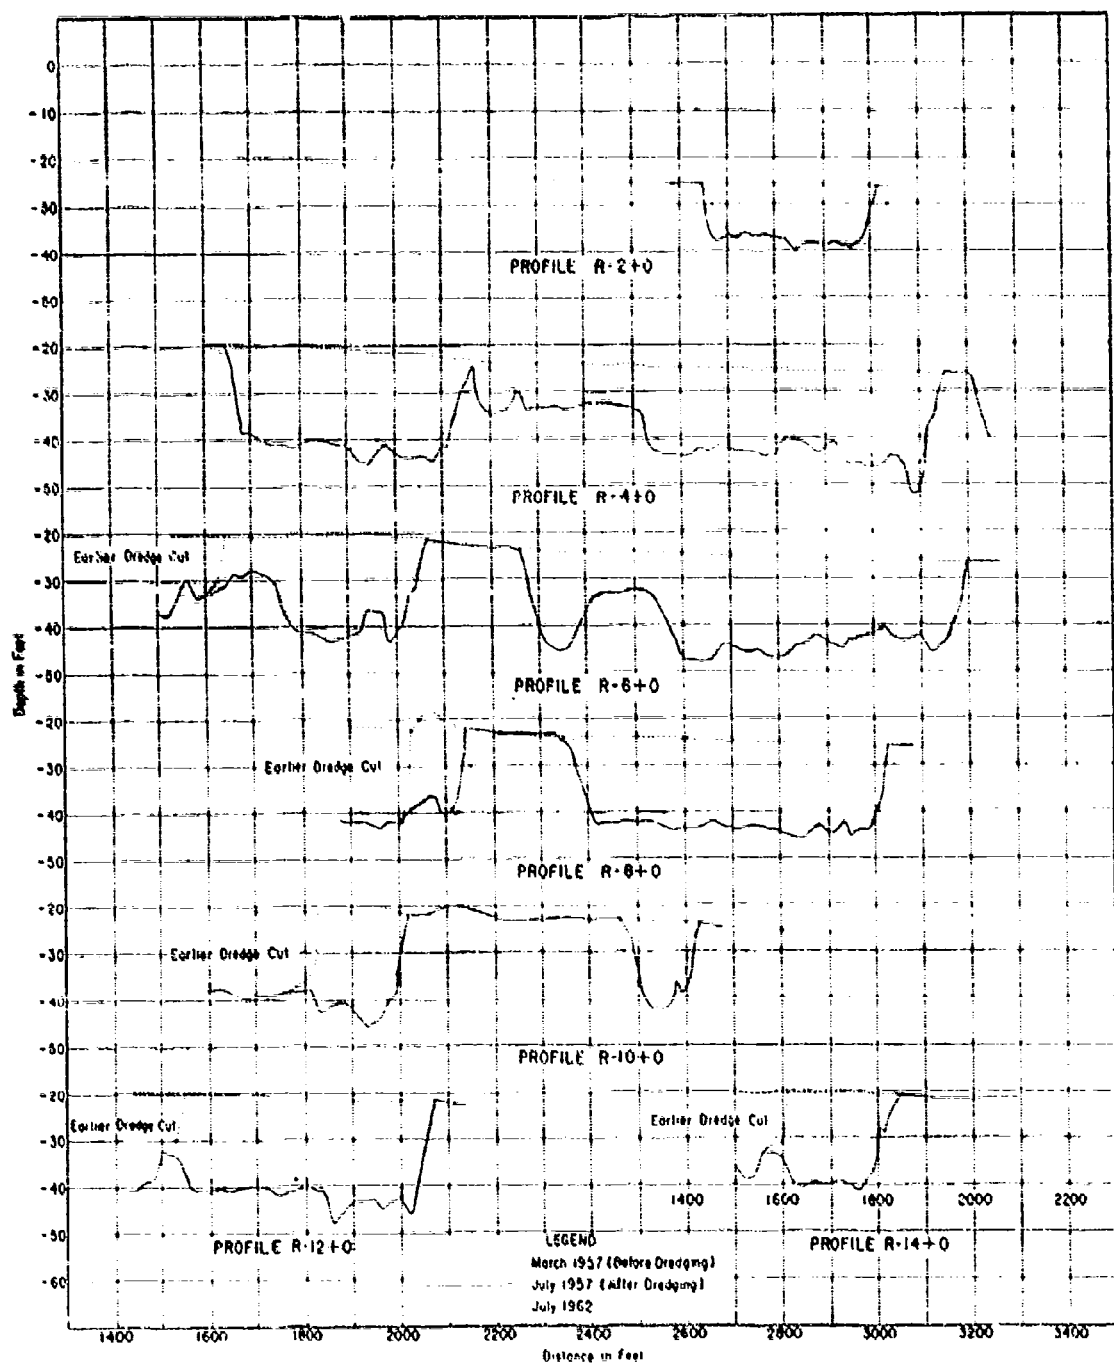
Figure 7. Comparative Ranges at Borrow Area

Prior to initial dredging in 1957, the borrow area was sounded along thirteen ranges spaced at intervals of 100 feet (ranges 2+00 to 14+00, inclusive) and again sounded in August 1957 after dredging. A line connecting Station C and Station F (Figure 2) was used as the base line of reference. These two sets of soundings were compared and the quantity of material excavated from the borrow area was computed to be 557,200 cubic yards. Of this quantity, 535,000 cubic yards were deposited on Sherwood Island Beach and 17,000 cubic yards were placed on Burial Hill Beach; the remaining 5,200, which represents a little less than one percent, can be accounted for by probable error in procedures used for measurement and computation, or losses during pumping.

The seven even-numbered ranges (2+00 to 14+00, inclusive) over the borrow area were sounded again in July 1962 to obtain an indication of the rate of natural refilling or shoaling. Comparative profiles plotted from these surveys are shown in Figure 7. Computations therefrom indicate that between August 1957 and July 1962 the borrow area shoaled 43,900 cubic yards or an average of about 8,800 cubic yards annually.

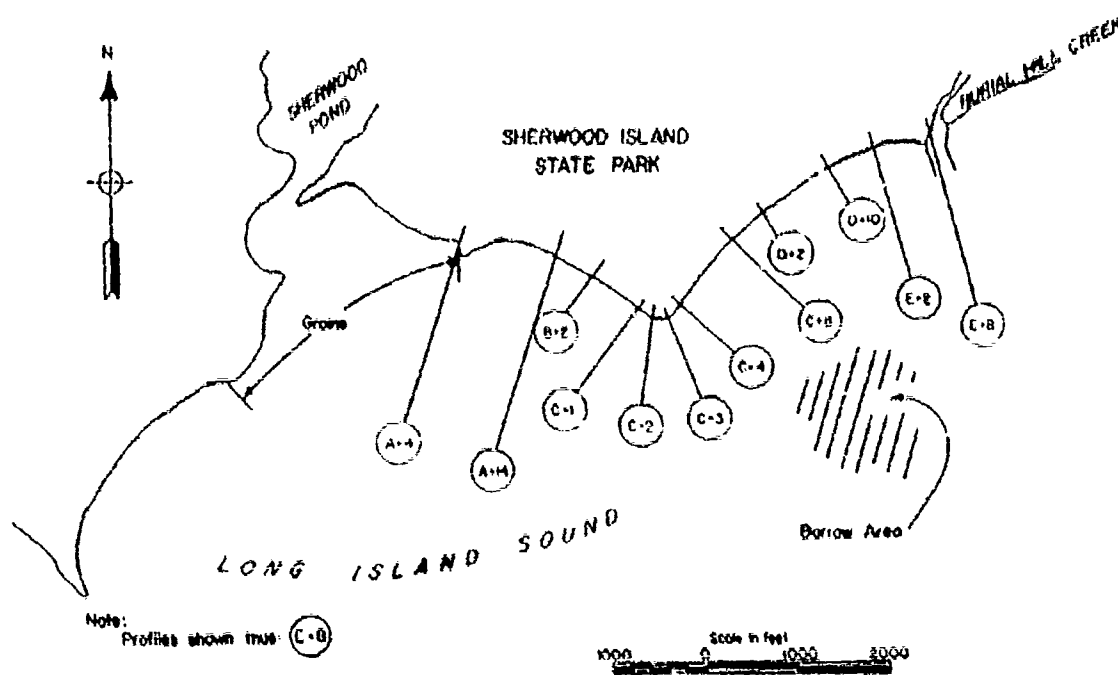
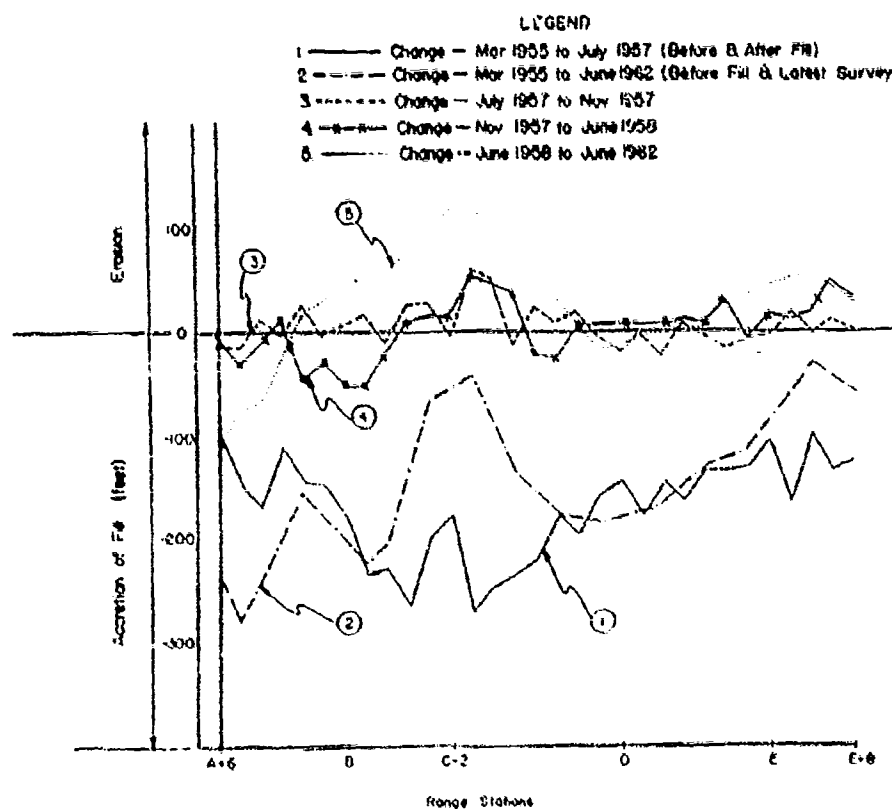
Figure 8. High Water Shoreline Changes

Changes in the mean high water and mean low water shoreline are shown graphically in Figures 8 and 9. There was little change in the position of the high water line from July 1957 (immediately after filling) to June 1958 except in the vicinity of Sherwood Point where the shoreline receded. East of the Point the high water shoreline was more or less stable, while west of the Point there was a small advance. Between June 1958 and June 1962 the high water shoreline receded at Sherwood Point and east of the Point, while it advanced in the area west of the Point. The net change in the high water shoreline by June 1962 was one of recession at Sherwood Point, advance in the western sector and little or no change in the eastern sector. Erosion at Sherwood Point was anticipated, however, and additional fill had been placed along the Point to create a stockpile to nourish the beach on either side. Although the high water shoreline had receded about 120 feet since fill placement, nowhere along the beach had it

receded to its position before Improvement. Changes in the low water line followed a pattern similar to that for the high water line; however, the net change was one of recession at Sherwood Point accompanied by little or no change in the eastern or western sectors.

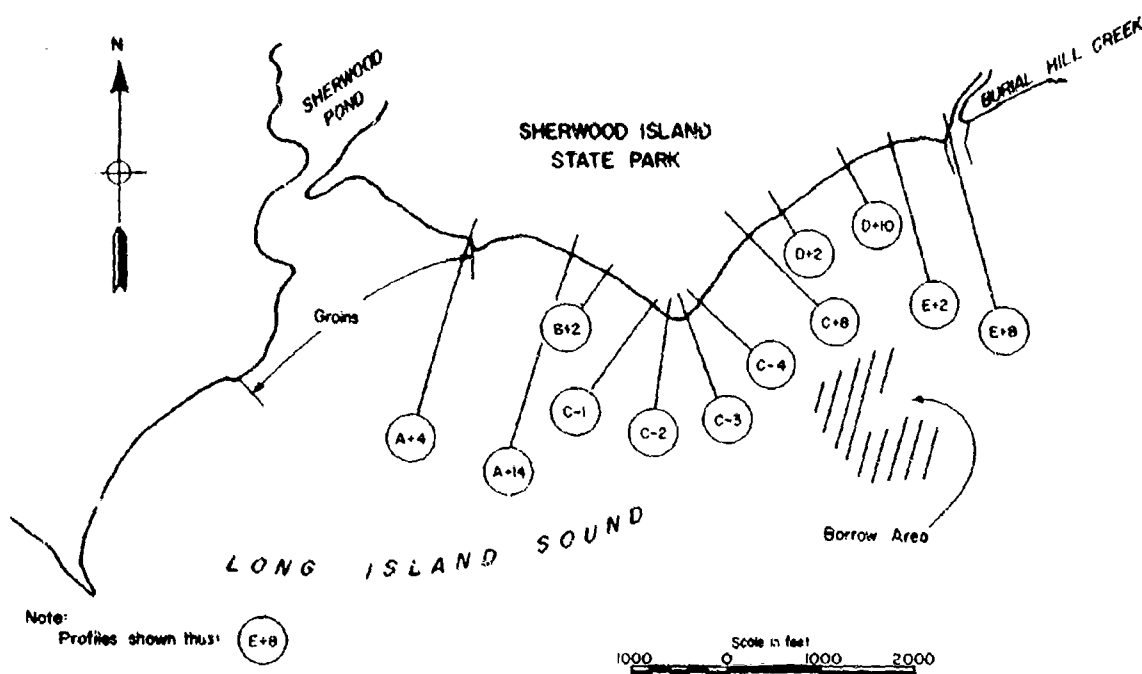
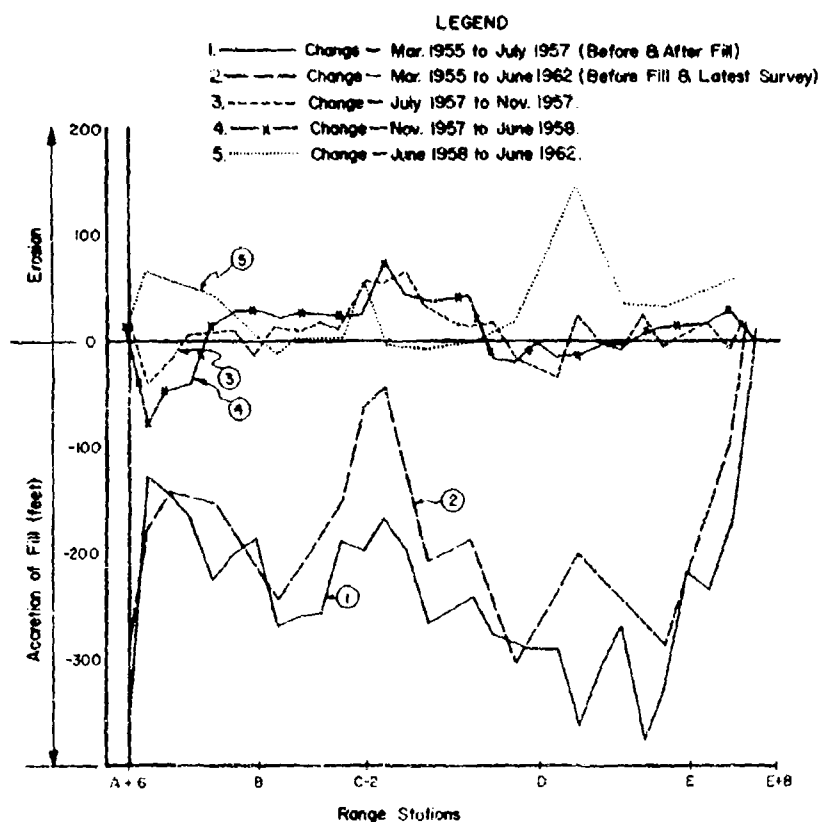
Figure 9. Low Water Shoreline Changes

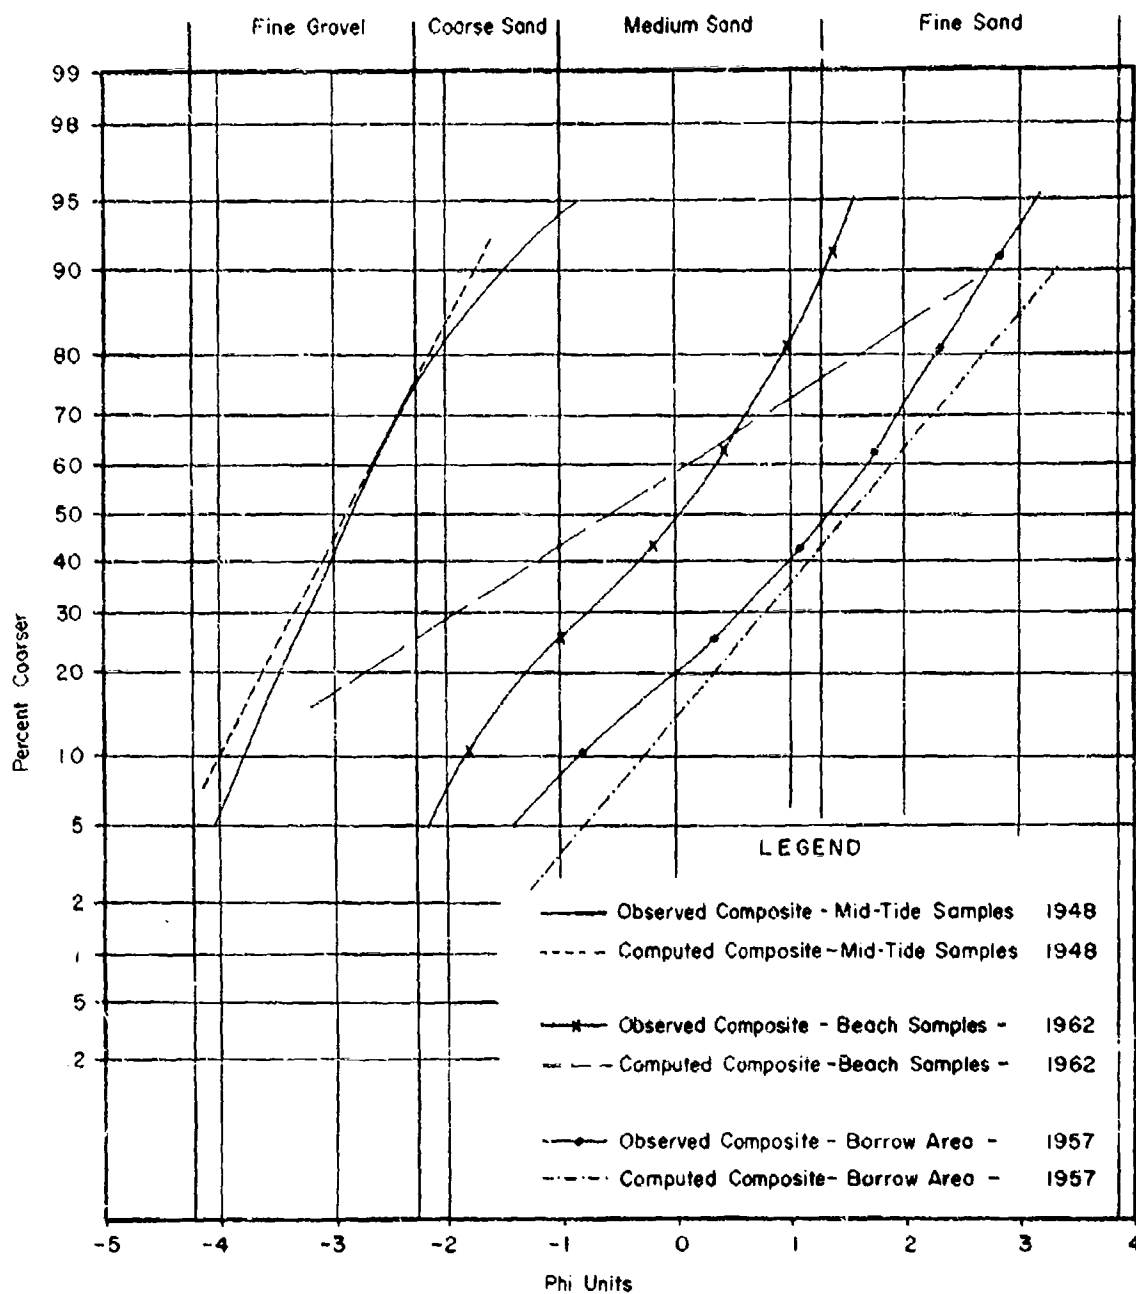
Figure 10. Composite Curves for Sand Samples

frequency and computed composite curves for the beach, borrow and midtide samples are shown in Tables 4 and 5, respectively, and plots of the curves are shown on Figure 10. The phi standard deviations for the computed curves for the 1962 beach, 1957 borrow and 1948 midtide samples, respectively, are 2.58, 1.41 and 0.88. The differences between these values are relatively large which indicates the variance in sorting between the beach material, borrow material and the midtide samples, the 1962 beach material being by far the most poorly sorted. A comparison of median diameter for the 1962 beach samples and samples of the borrow material (Figure 10) shows that the composite median diameter of the beach samples is much larger. This would indicate that there had been mixing of the fill material with the coarser material composing the original native beach and that also much of the finer size material may have been lost from the fill during placement or by subsequent action of littoral forces. Normally, when entire class fractions are removed from the size-class distribution of a mixture of material, the remaining material exhibits better sorting. For the 1962 beach samples, the indicated poor sorting, as well as coarseness (in some degree), are believed to be derived from the mixing of the fill material with the coarser native beach material.
